**Flood Control Project Maintenance
Levee Inspections**

Maintenance Issue Types Only, Levee Inspection Report By Mile - Spring 2015

Reclamation District No. 0341 Sherman Island

Waterway	Bank	Unit Miles	Inspection Start/End	Inspector
Unit No. 01 Threemile Slough	Right	3.36	03/30/2015 03/30/2015	Herman Phillips

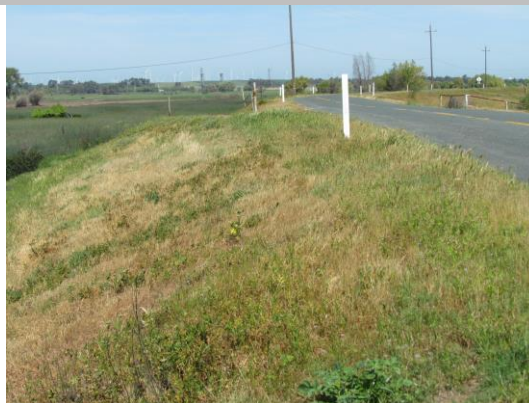
Photo 1 of 1 : SP_2015_RD0341_167_390_20150406_00070.jpg

LM Start	0.00	Rating **	A	Issue No.	390
LM End	3.31	Issue Type +	Ma	Location *	LS
Category	Earthen Levee			GPS Latitude/Longitude	
				Start	End
Item	Vegetation			38.085595 °	38.105183 °
				-121.686437 °	-121.702030 °
DWR ID	DWR_RD0341_01_s_2015_390				
Action/Comments					
Control annual grass and weeds on the levee slopes and easements. Inspector Comments: During this inspection the district was in the process of mowing levee slopes.

Looking downstream at the landside.

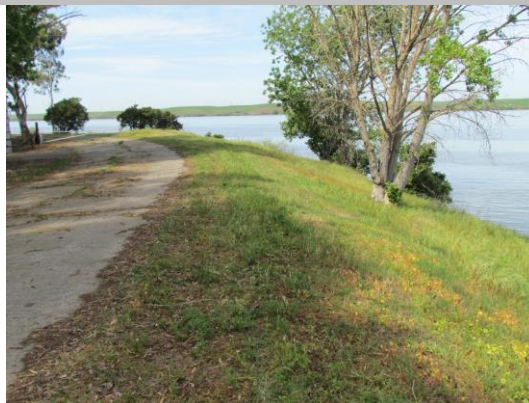
Photo 1 of 1 : SP_2015_RD0341_168_2_20150406_00128.jpg

LM Start	3.34	Rating **	A	Issue No.	2
LM End	3.37	Issue Type +	Ma	Location *	WS
Category	Earthen Levee			GPS Latitude/Longitude	
				Start	End
Item	Vegetation			38.105130 °	38.105313 °
				-121.702000 °	-121.702713 °
DWR ID	DWR_RD0341_02_s_2015_2				
Action/Comments					
Control annual grass and weeds on the levee slopes and easements. Inspector Comments: District mowed this section of levee slope prior to my inspection.

Looking downstream from the waterward slope levee mile 3.34.

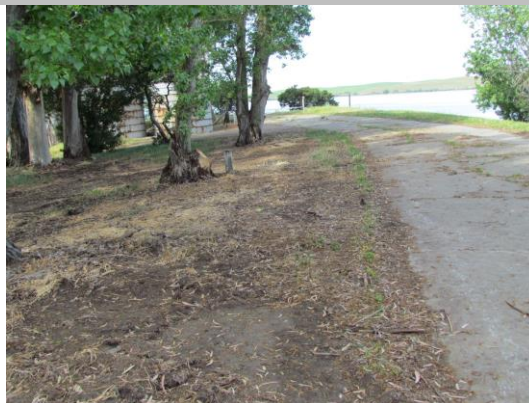
Photo 1 of 1 : SP_2015_RD0341_168_4_20150406_00129.jpg

LM Start	3.37	Rating **	A	Issue No.	4
LM End	3.38	Issue Type +	Ma	Location *	LS
Category	Earthen Levee			GPS Latitude/Longitude	
				Start	End
Item	Vegetation			38.105313 °	38.105358 °
				-121.702713 °	-121.703030 °
DWR ID	DWR_RD0341_02_f_2014_4				
Action/Comments					
Control annual grass and weeds on the levee slopes and easements.

Looking downstream from landside.

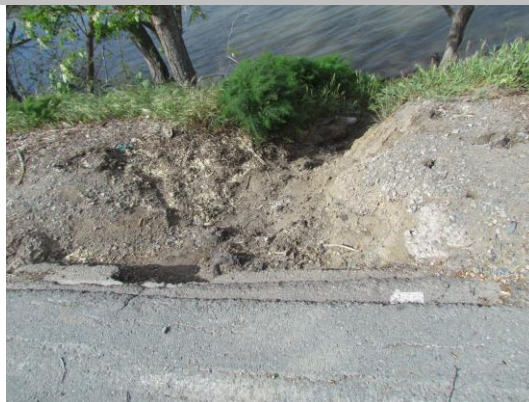
Photo 1 of 2 : SP_2015_RD0341_168_599_20150406_00126.jpg

LM Start	5.53	Rating **	U	Issue No.	599
LM End	5.53	Issue Type +	Ma	Location *	WS
Category	Earthen Levee			GPS Latitude/Longitude	
				Start	End
Item	Erosion / Bank Caving			38.081297 °	38.081297 °
				-121.719400 °	-121.719400 °
DWR ID	DWR_RD0341_02_s _ 2015_599				
Action/Comments					
Note and monitor erosion site.					
Inspector Comments: This erosion needs to be repaired.

Erosion greater than 6" on waterside shoulder.

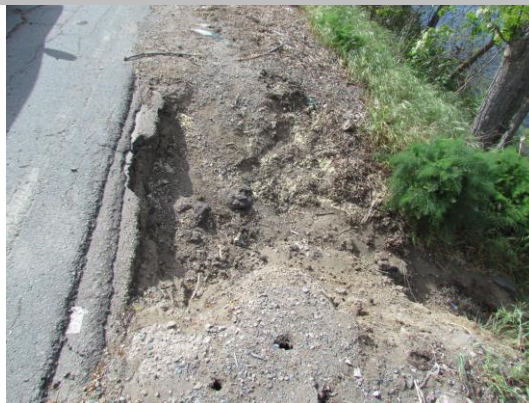
Photo 2 of 2 : SP_2015_RD0341_168_599_20150406_00127.jpg

LM Start	5.53	Rating **	U	Issue No.	599 (cont)	
LM End	5.53	Issue Type +	Ma	Location *	WS	
Category	Earthen Levee			GPS Latitude/Longitude		
				Start		End
Item	Erosion / Bank Caving			38.081297 °	38.081297 °	
				-121.719400 °	-121.719400 °	
DWR ID	DWR_RD0341_02_s_2015_599					
Action/Comments						
Note and monitor erosion site.						
Inspector Comments: This erosion needs to be repaired.

View from upstream of erosion site.

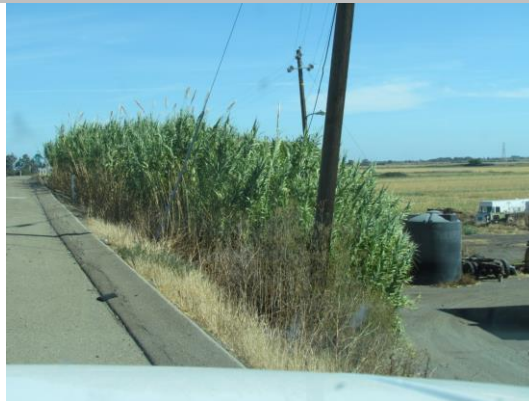
Photo 1 of 1 : SP_2015_RD0341_168_12_20150312_00005.jpg

LM Start	6.30	Rating **	U	Issue No.	12
LM End	6.32	Issue Type +	Ma	Location *	LS
Category	Earthen Levee			GPS Latitude/Longitude	
				Start	End
Item	Vegetation			38.081078 °	38.081133 °
				-121.732975 °	-121.733445 °
DWR ID	DWR_RD0341_02_f_2014_12				
Action/Comments					
Remove the wild growth other than native grasses from the levee slopes.					
Inspector Comments: Remove the Aurondo from the landside levee slope.

Unwanted arundo present on the levee slopes landward slope looking upstream.
